## **Life in the Atacama Field Journal**

September 15, 2005

Salar de Navidad and Antofagasta, Chile

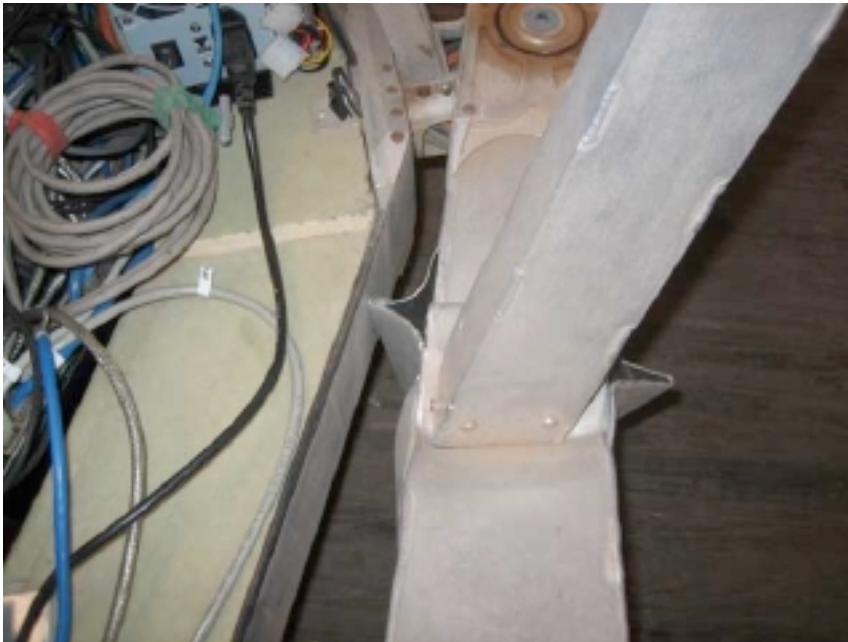
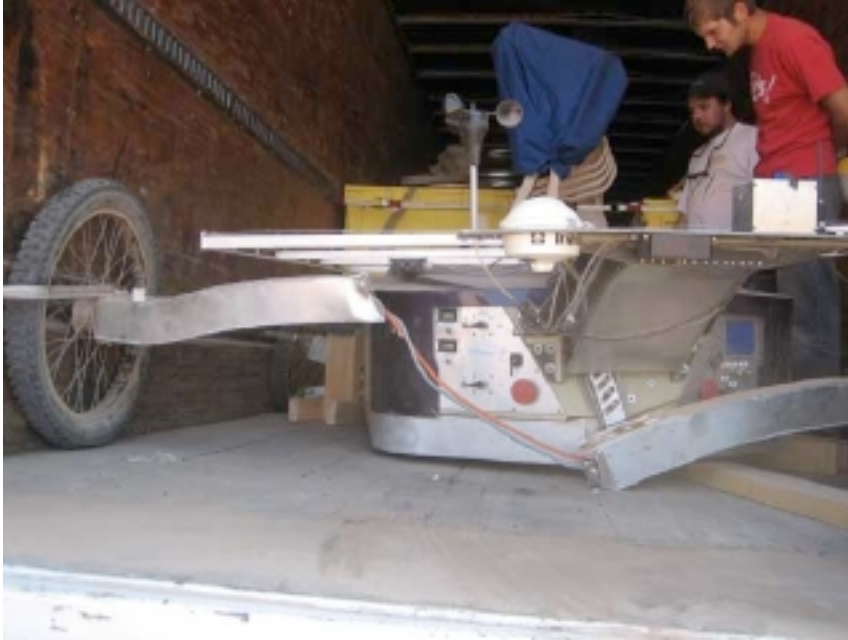
- Zoë severely damaged. Upon arrival at the cargo drop location for our Site E investigation at Salar de Navidad it was immediately clear that Zoë had been damaged by the ride in the cargo transport from Salar Grande. This is a drive of over 400km with many kilometers over rough road. Both of the axles had buckled and the rear axle sheared off. We are still investigating the factors involved but it would appear that prolonged vibration and loading of the axles by the body mass, assuming that the supports for the body had been shaken loose by the ride, produced stress on the axles. (Failure aside, we have learned a weak point in the design and can correct it in the future.)

- Zoë systems assessed and repair planned. The Universidad Catolica del Norte in Antofagasta quickly arranged for the use of a garage to unpack and examine Zoë. Minor damage was found and repaired on the Fluorescence Imager. A cable for the spectrometer has been damaged and will be swapped out. All electronic systems have checked out. It appears that the only damage is to the axles.

The machined components that mate the axle to the body have been removed from the damaged axles. A spare set of axles in Pittsburgh are being strengthened and prepared to accept the mating parts. We will be assembling new axles and getting them to Chile by Monday, September 19.
